NDI No. PA 00220

ROYAL RESERVOIR DAM

PHASE I INSPECTION REPORT NATIONAL DAM INSPECTION PROGRAM

JULY 1980 03 136

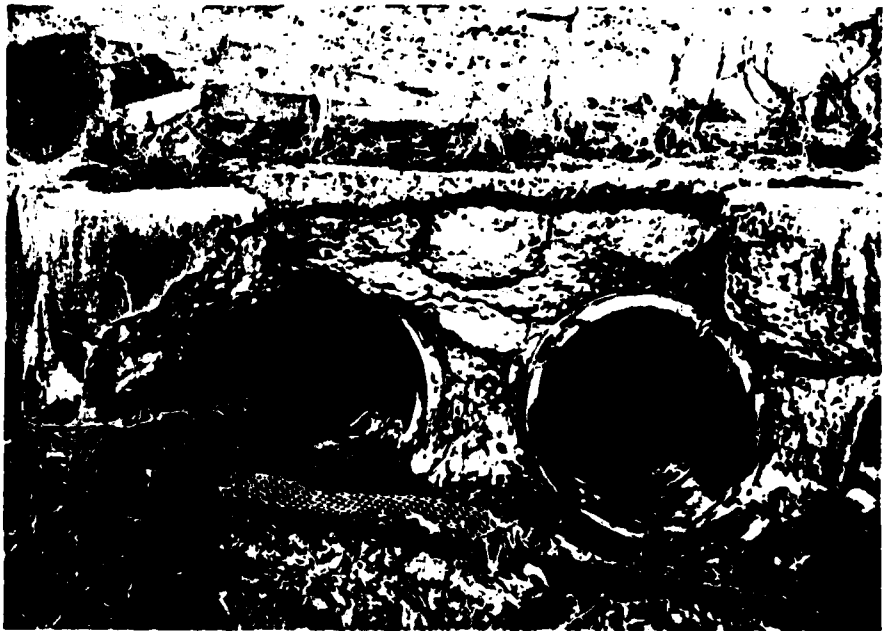
PHOTO 5. PRINCIPAL SPILLWAY INLET

c. Principal Spillway: The principal spillway for Royal Reservoir Dam is considered to be in poor condition. This is based on the observed lack of a trash rack or trash boom to control clogging of the inlet.
